Assessment of Dam Safety

Coal Combustion Surface Impoundments (Task 3)

Final Report

JM Stuart Station

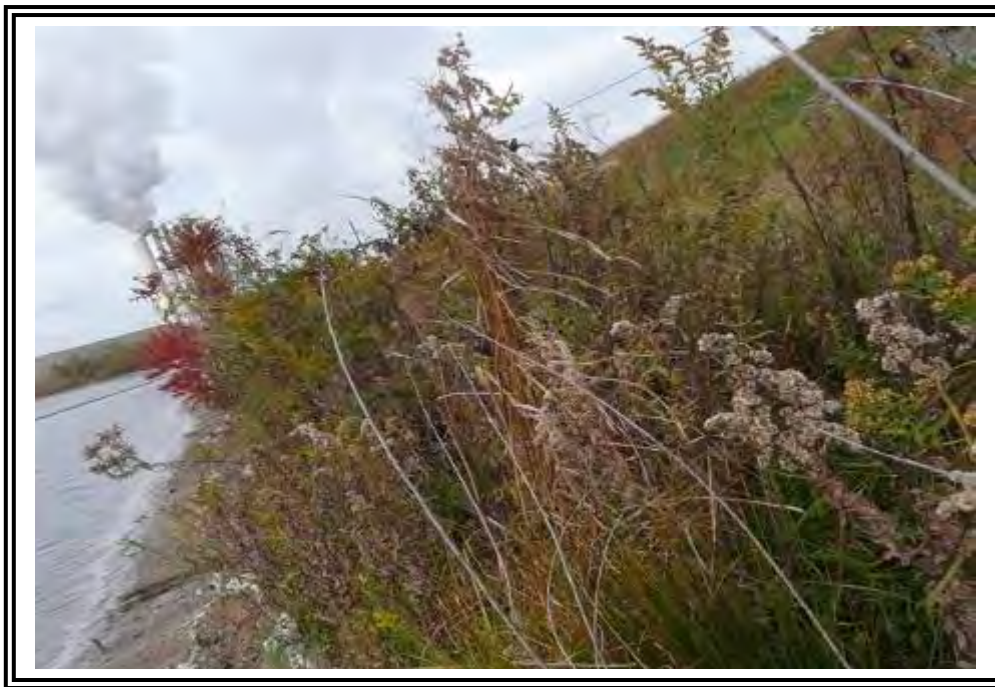
57

The north wall of the pond appears to be at the approximate foundation level for Landfill 11 (formerly Pond 8) as seen in Photo 61. This area is moderately to heavily vegetated with weeds, grasses, brush, and smaller trees (Photos 56, 57, 59, and 62). The pond level was down slightly during the site visit, and some beaching erosion was visible as noted in Photos 58 and 59. Standing water was also encountered intermittently in this area (Photo 60), but this was likely due to the recent rains, sheet-flow runoff from the landfill, and the fairly flat topography in the area between Pond 6 and Landfill 11.

Moderate to heavy weedy, brushy vegetation on north incised wall of Pond 6, looking west.

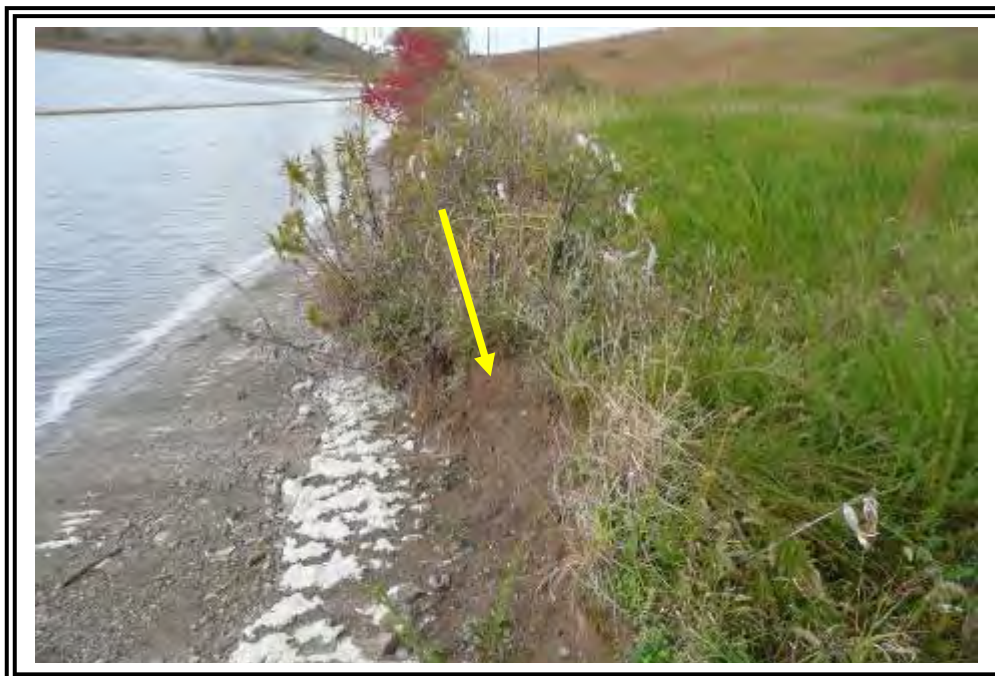
58

Looking west at beaching erosion (arrow) on north incised wall of Pond 6.
Recent high water level is evident from deposited ash in picture.

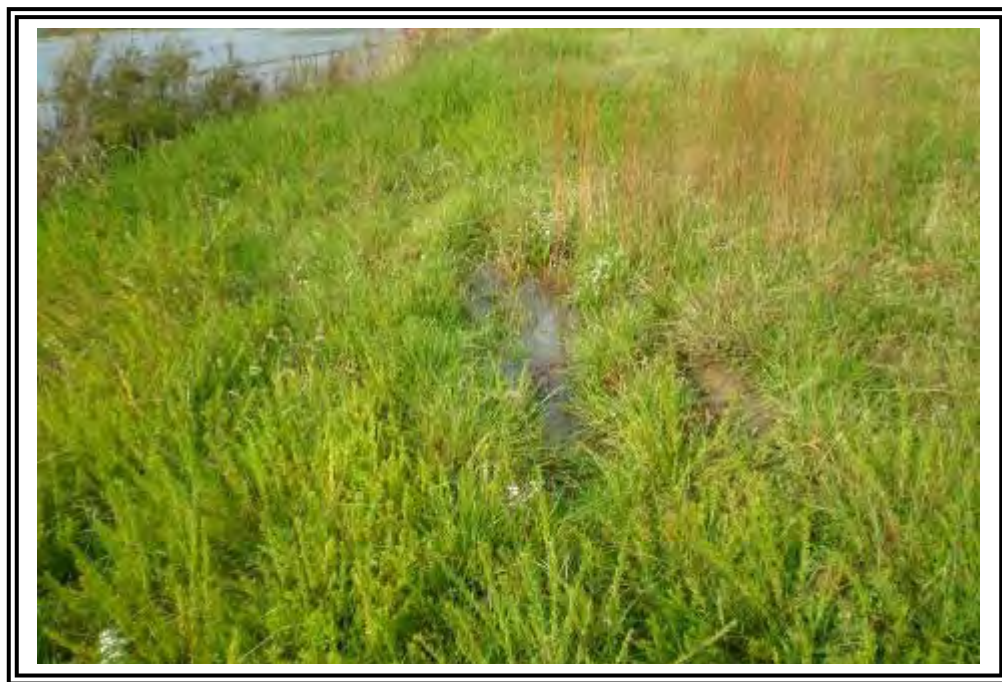
60

Standing water in grass and weeds adjacent to north wall of Pond 6.

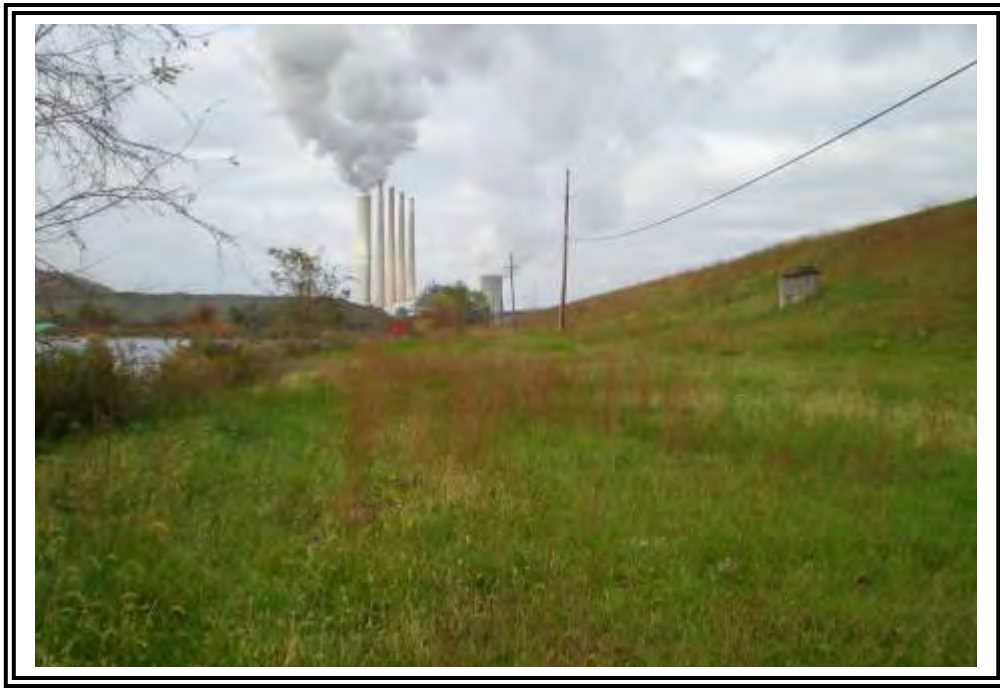
61

Looking west along the northern side of Pond 6. Landfill 11 is off the right side of photo.

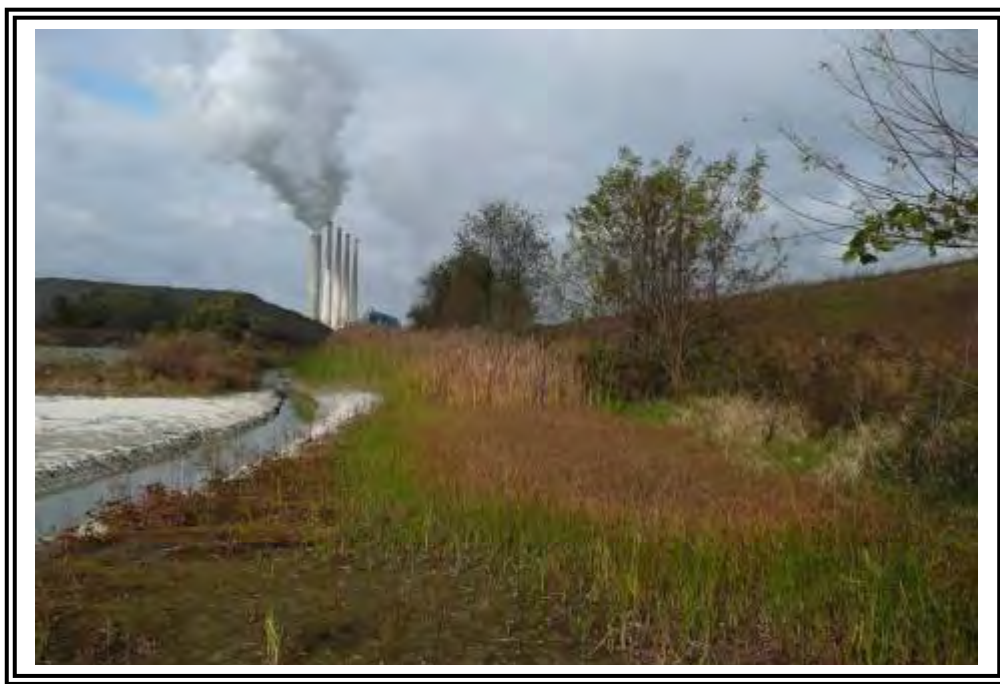
62

Looking west along the northern side of Pond 6 from a point farther west than shown in Photo 61.

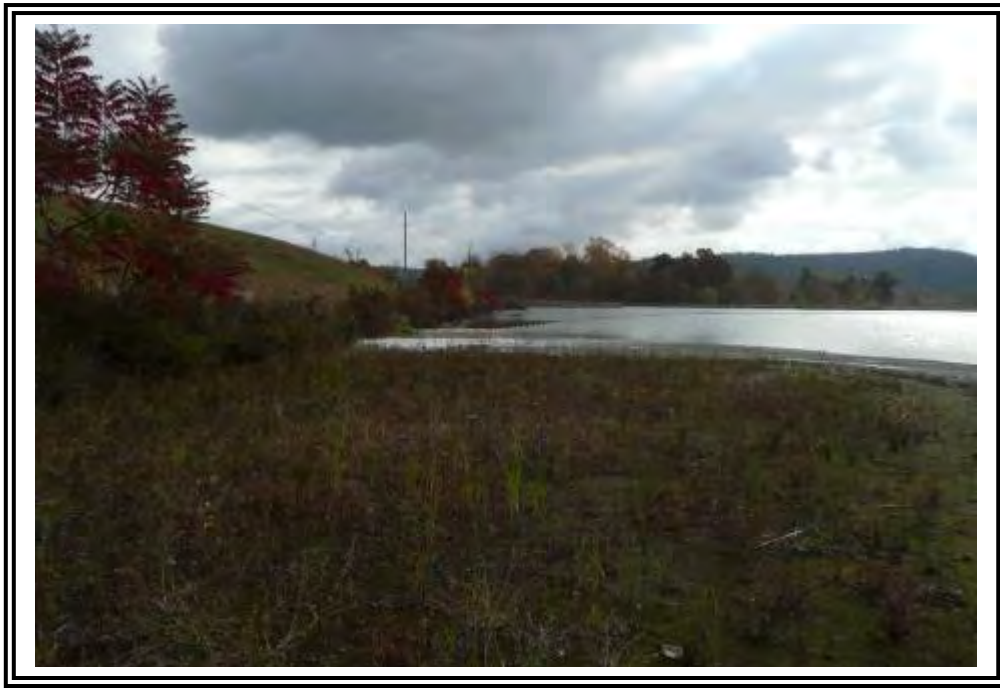
63

Looking east along the north edge of Pond 6 from the northwest end of pond.

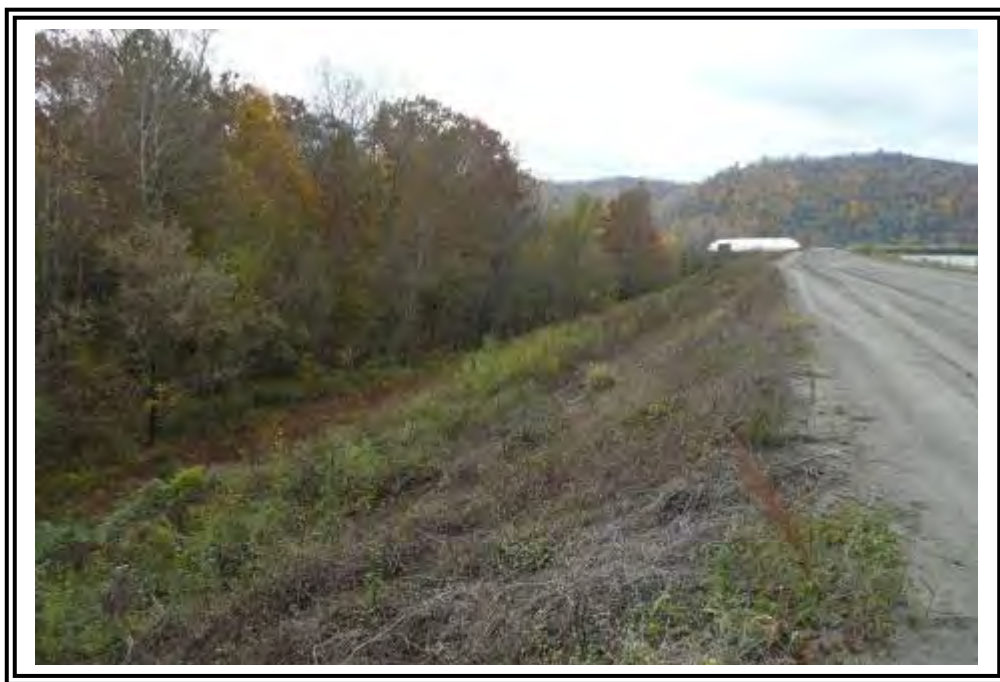
64

Looking south along the downstream slope of the east dike of Pond 6.

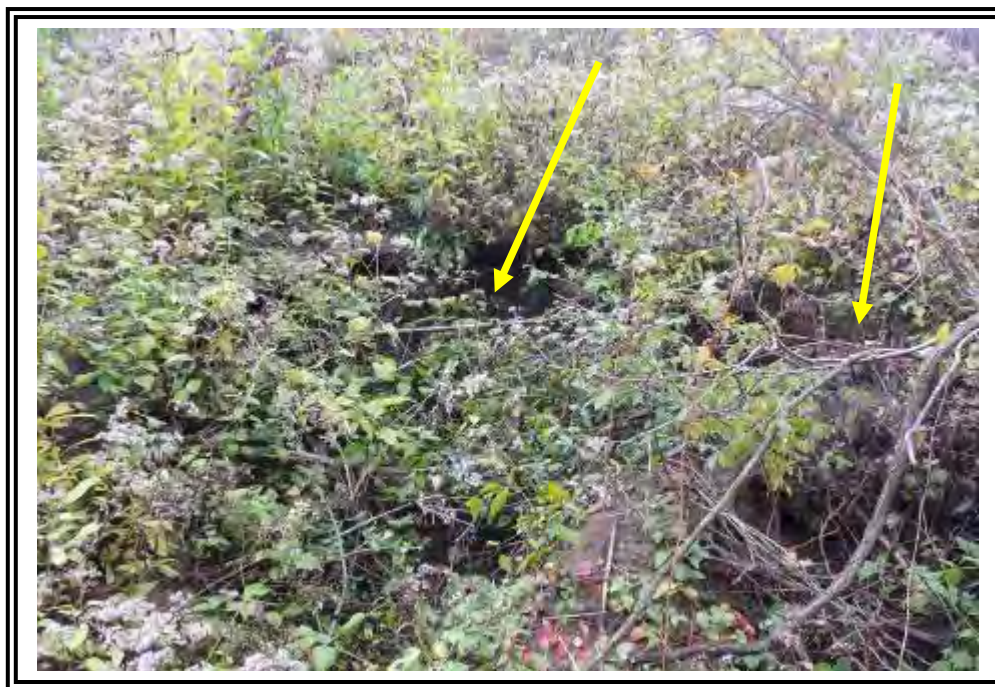
65

Deep, heavily vegetated erosion gullies on downstream east dike slope of Pond 6.
These were 3.5 to 4 feet deep located near the north end of the dike.

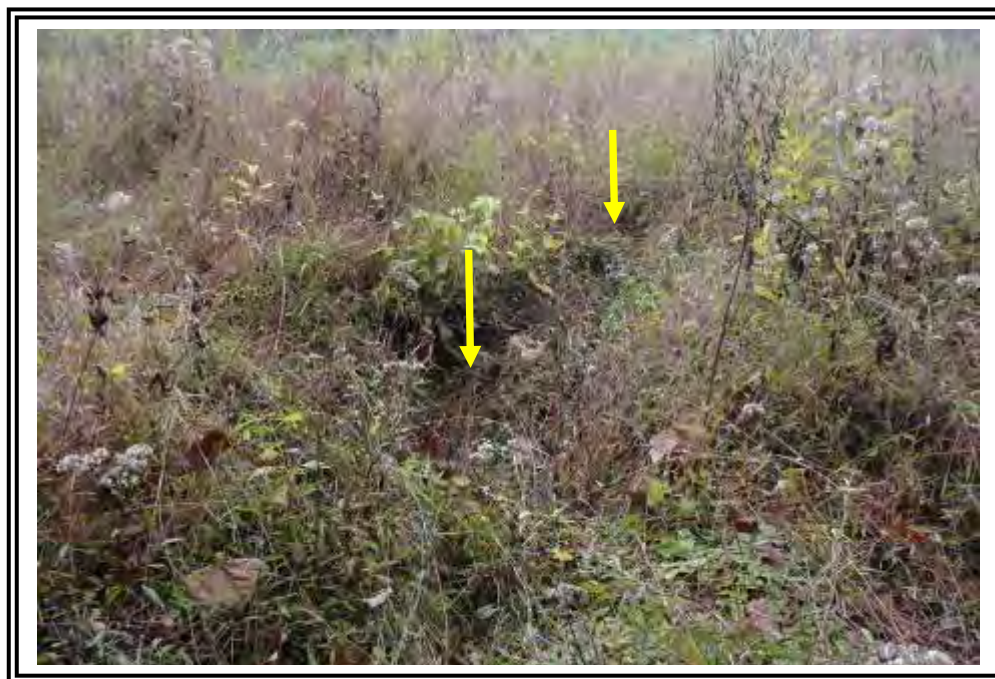
66

Vegetated erosion rill on downstream slope toward the center of the east dike of Pond 6
approximately 1.0 to 2.0 feet deep.

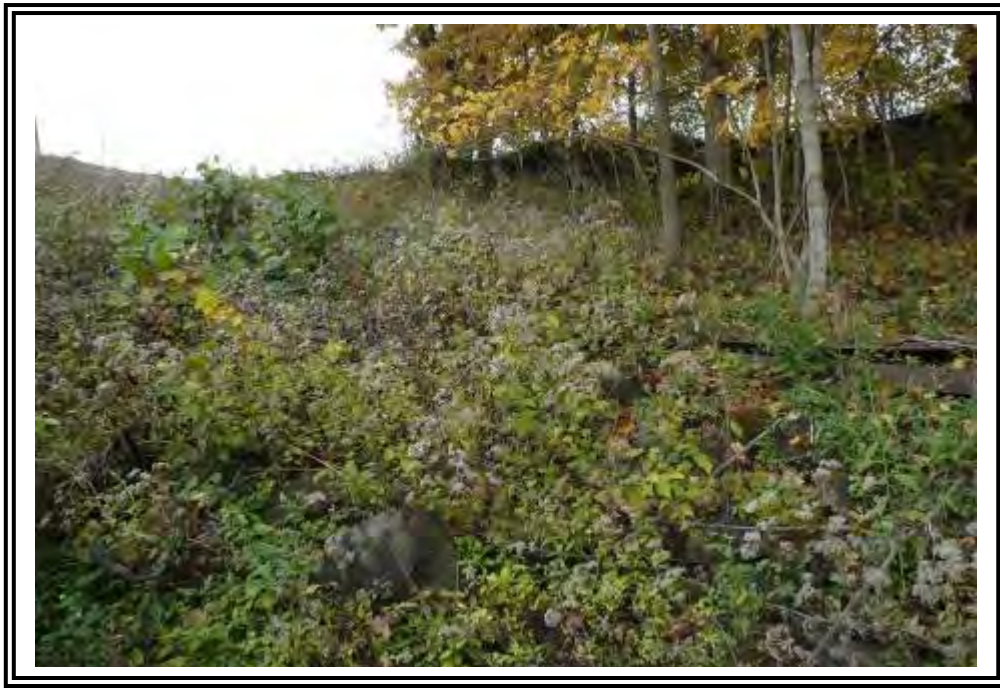
67

Looking up the downstream slope at the start of the eastern dike at Pond 6.
Vegetation obscures rock groin in this area.

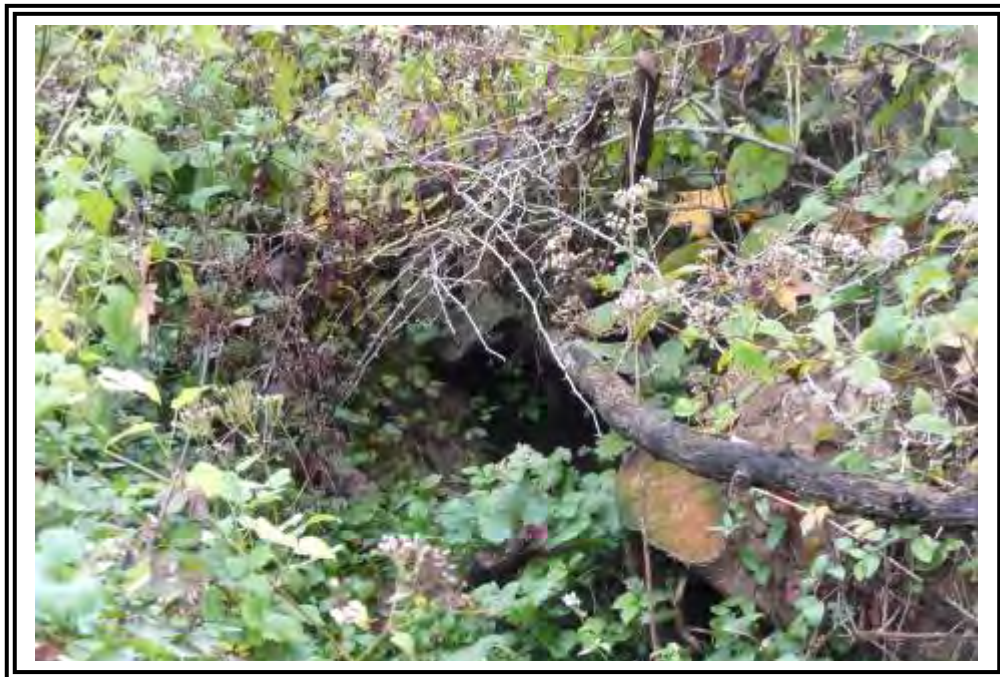
68

Close up of a possible rodent burrow or animal cave in the dense vegetation on the
downstream slope of Pond 6 east dike.

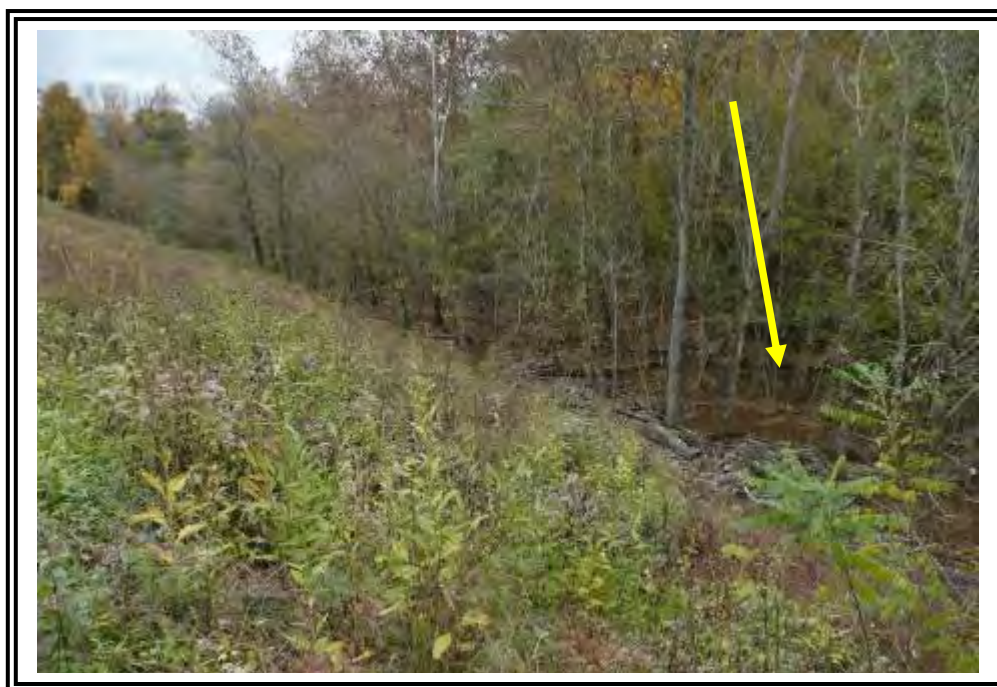
69

Downstream east dike slope of Pond 6, looking north from mid-slope.
Creek area at toe on right side of photo (arrow).

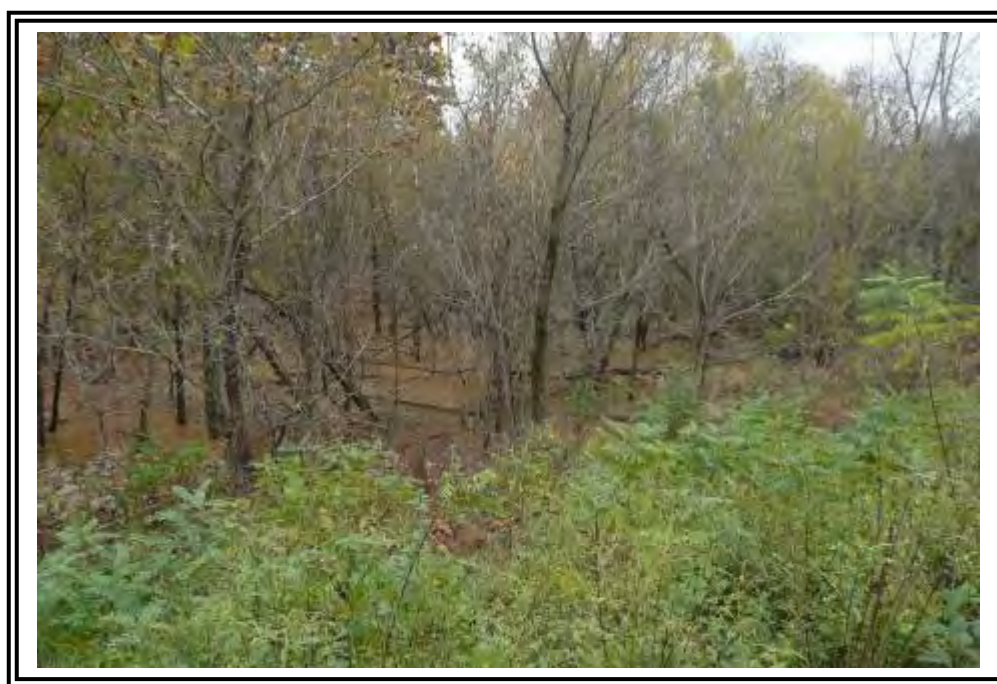
70

Another view of water in creek backing up against downstream toe on east dike of Pond 6.

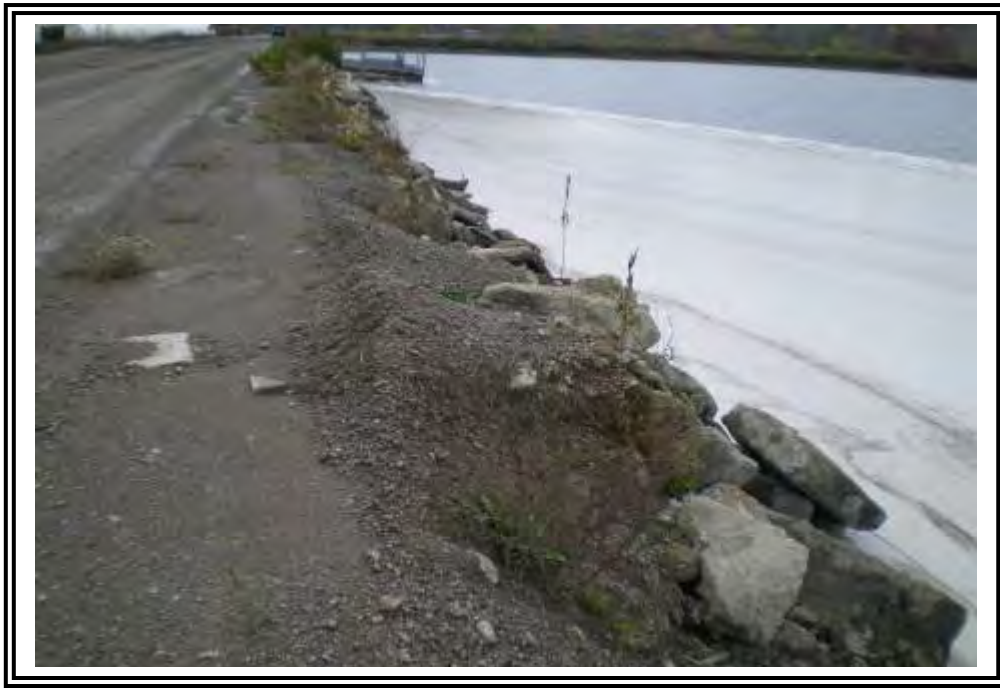
71

Looking south along the Pond 6 east dike crest and upstream slope toward the old outfall structure.

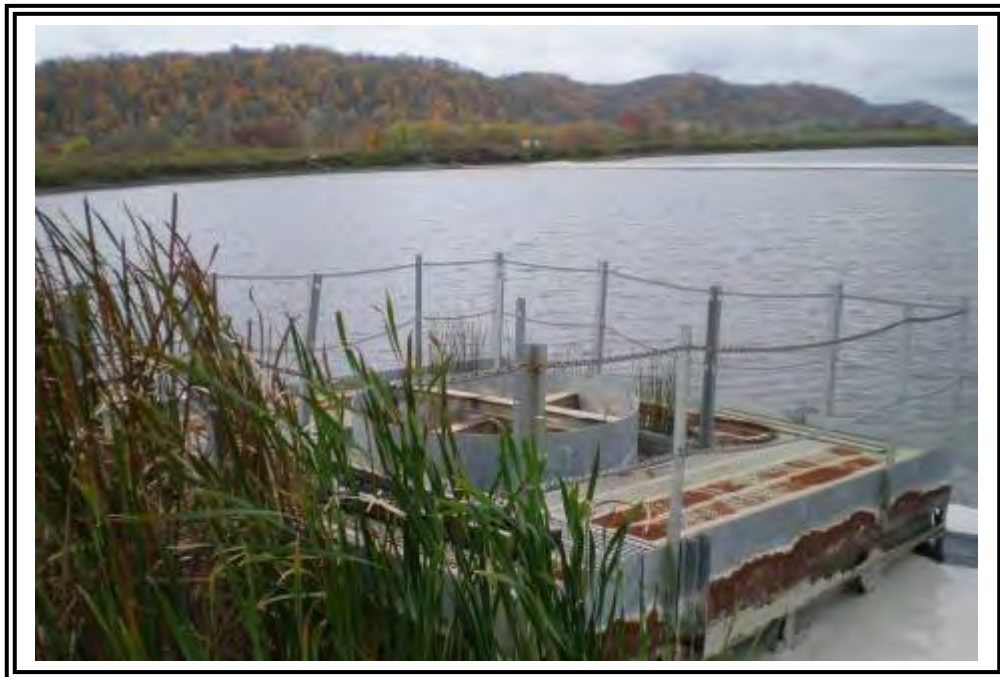
72

Close up of the old outfall structure.

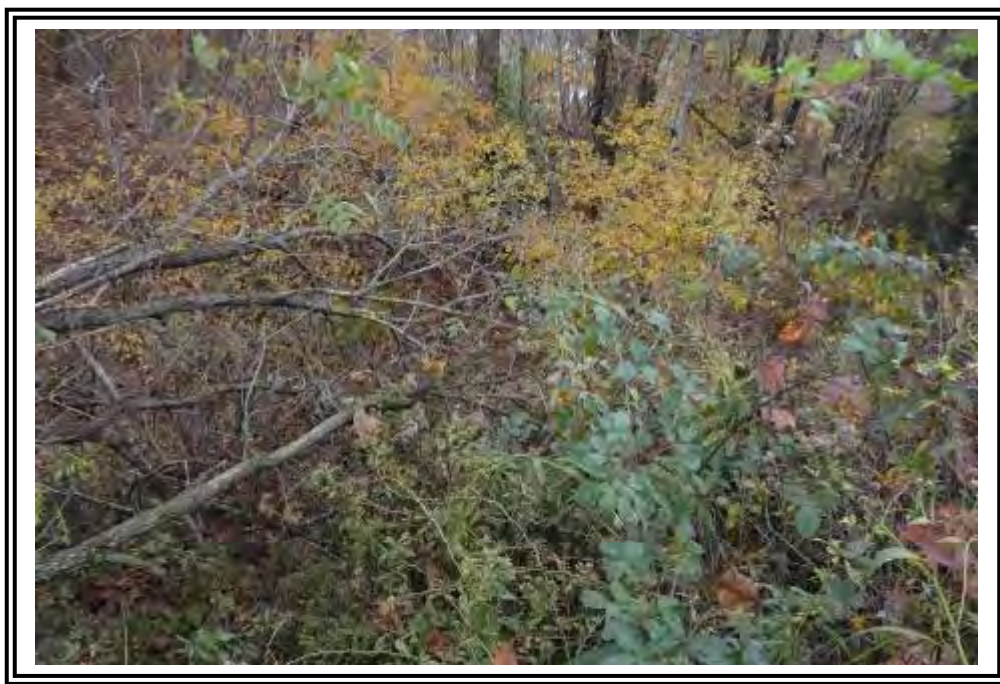
Dense to very dense vegetation on the downstream slope of Pond 7/7A east dike.

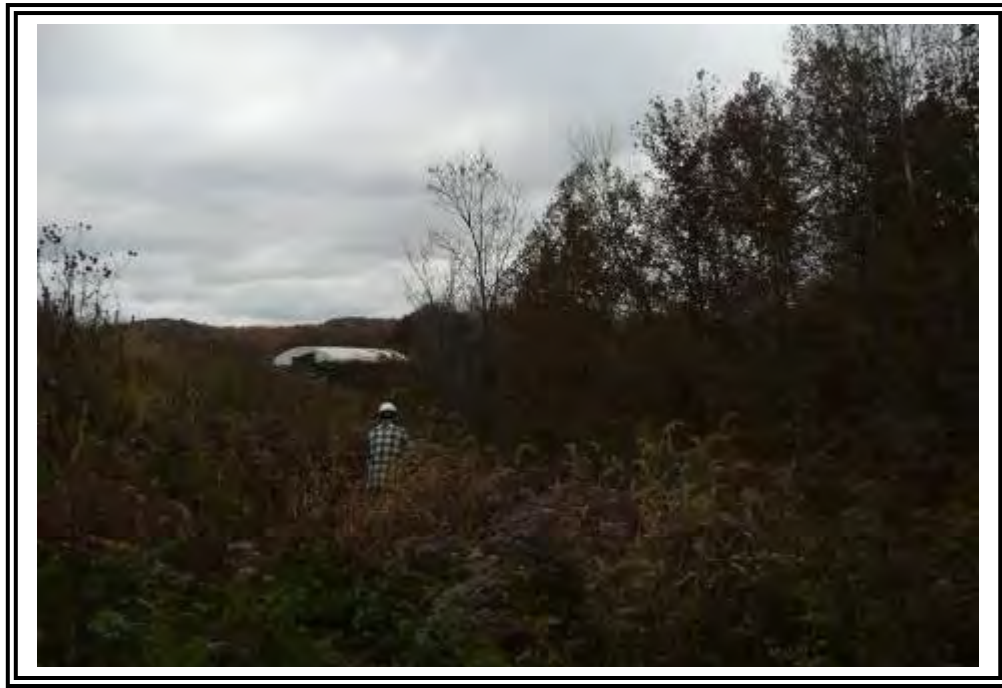
75

Looking north along the downstream slope of the east dike of Pond 7A.

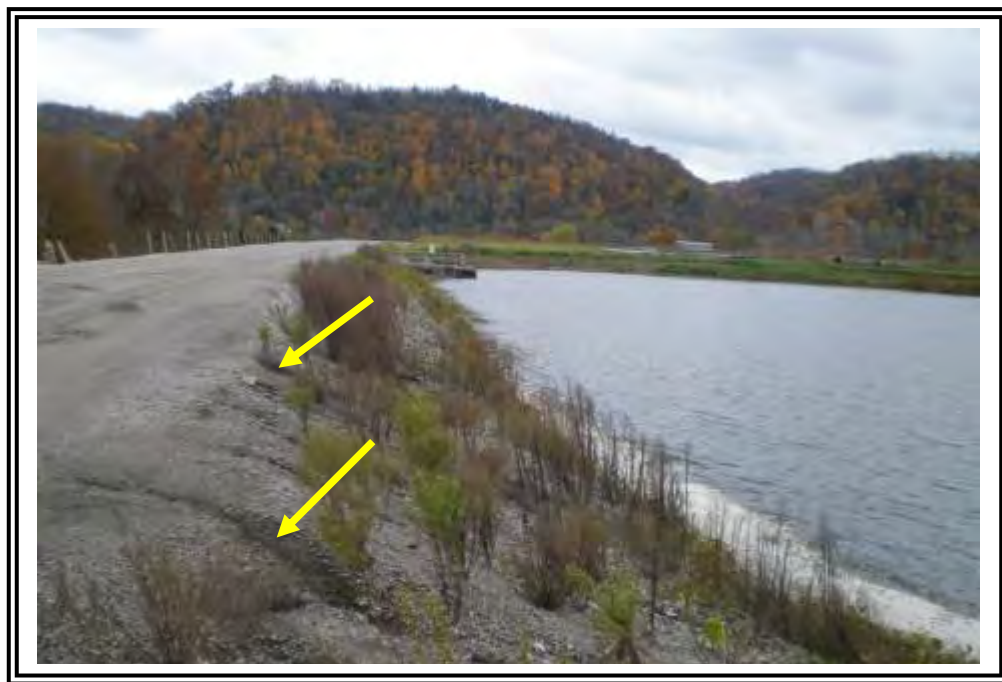
76

Looking south along the crest and upstream slope of the Pond 7A east dike.
Note the erosion rills at the crest (arrows).

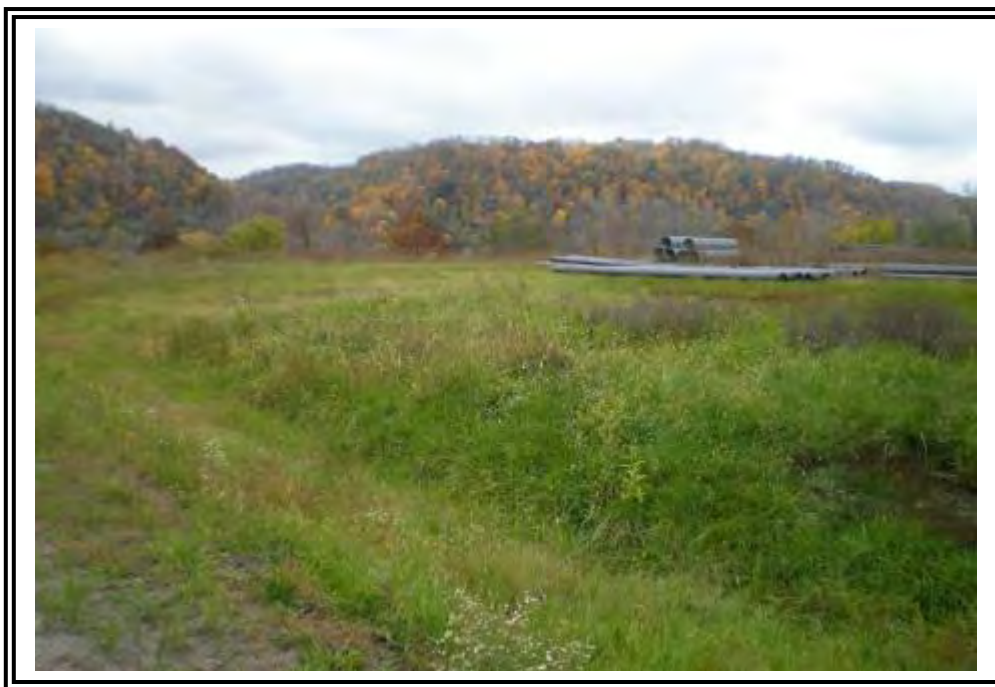
77

Looking southwest from east dike crest across portion of Pond 7 filled in to form Pond 7A.
Note grassed lay down area.

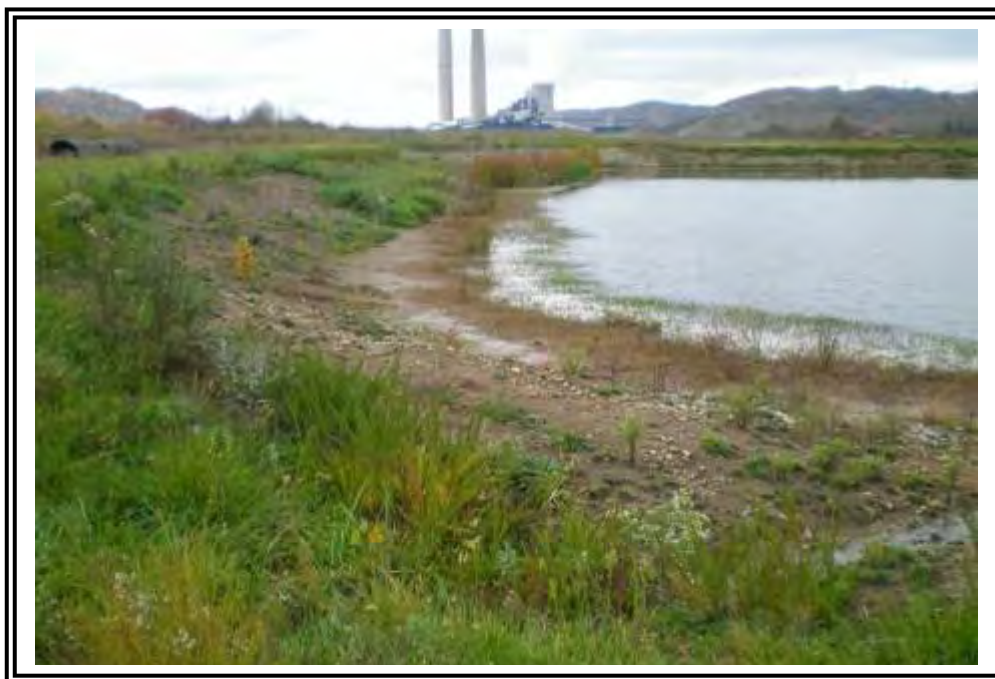
78

Looking west along south side of Pond 7A and filled in portion of Pond 7.

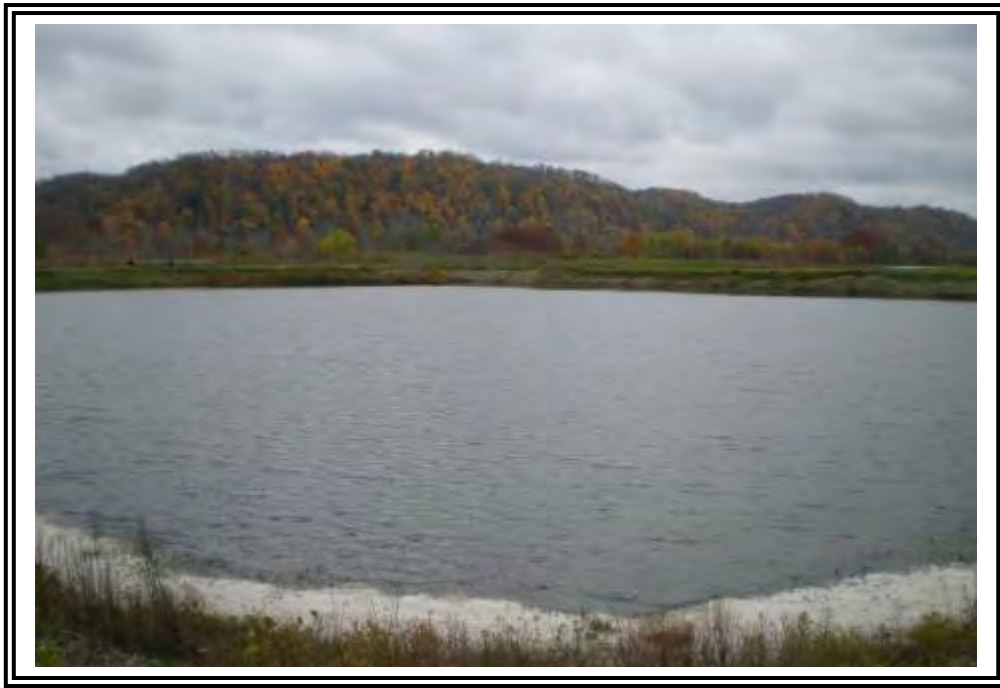
79

Looking southwest across Pond 7A from the northeast corner.

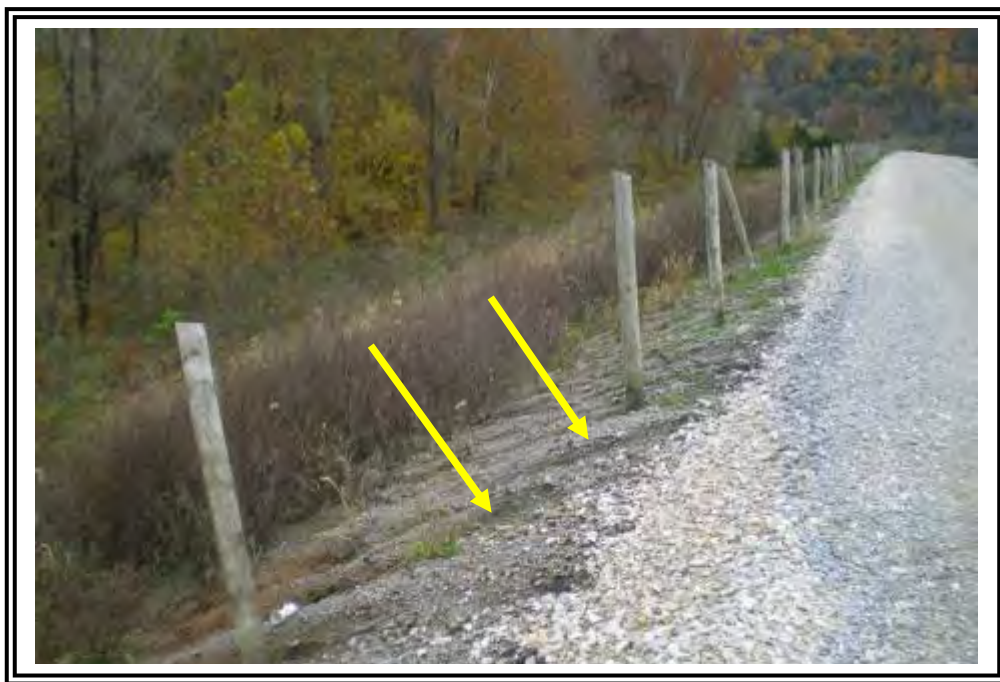
80

Looking south along the crest and downstream slope of the east dike. Note erosion rills near crest (arrow).

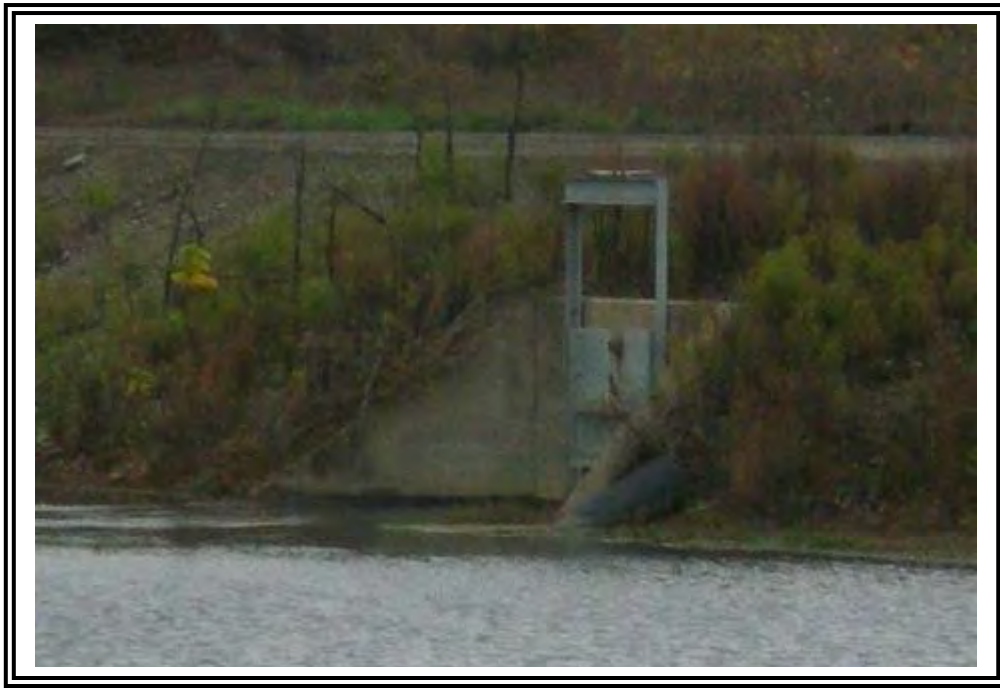
81

Looking northerly toward the influent gate in Pond 7A from the treatment station and outfall on Pond 6.

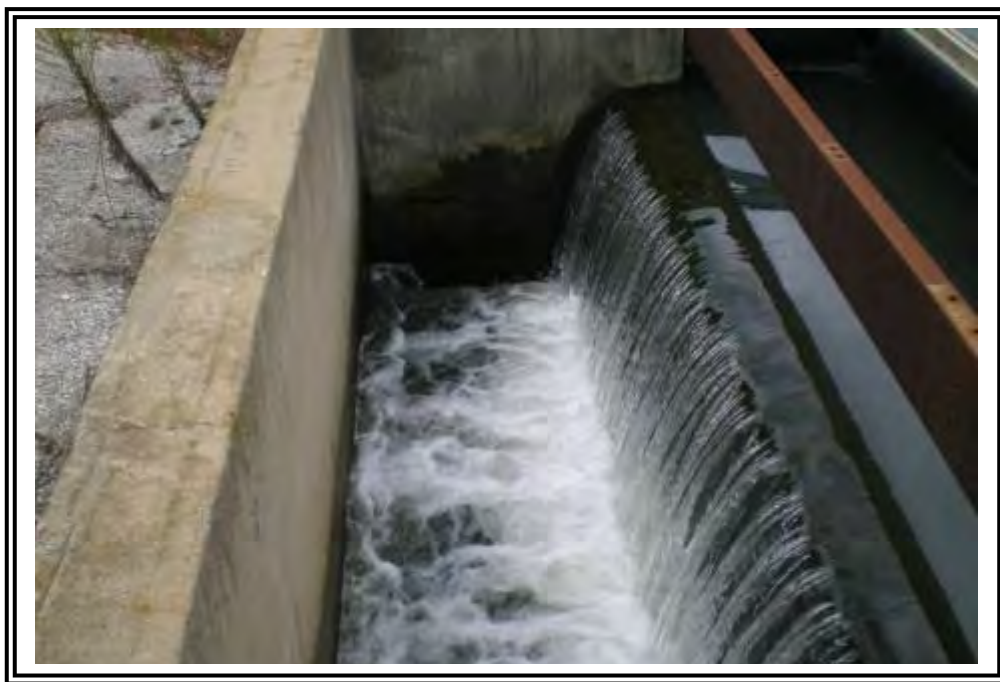
82

Close-up of outfall structure at Pond 7A.

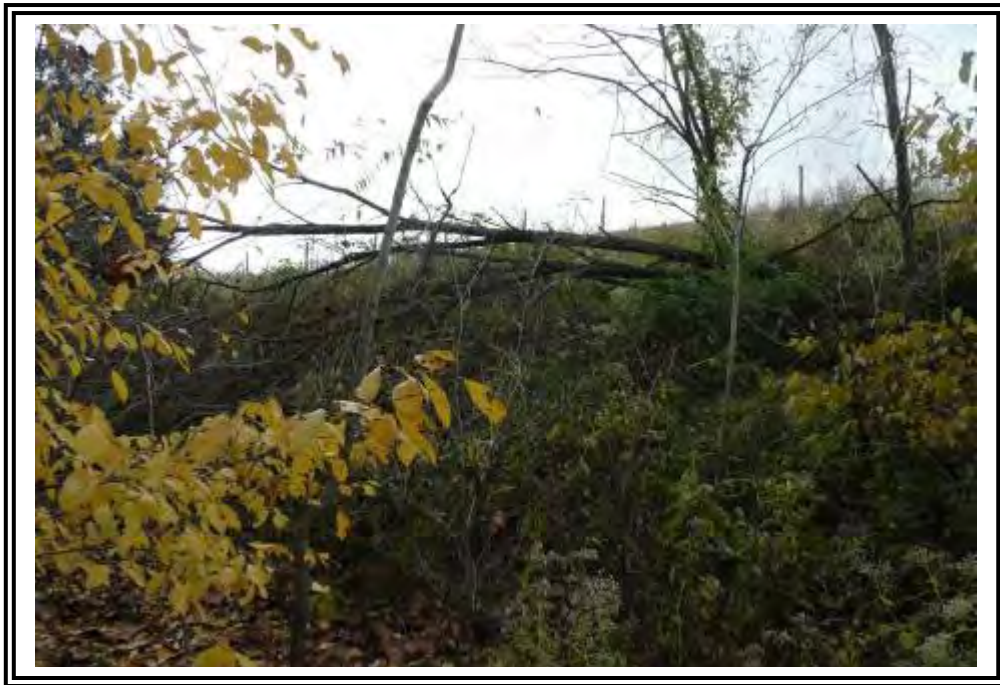
83

Looking up the slope of the Pond 7 south dike along the Ohio River near the location of the outfall into the river.

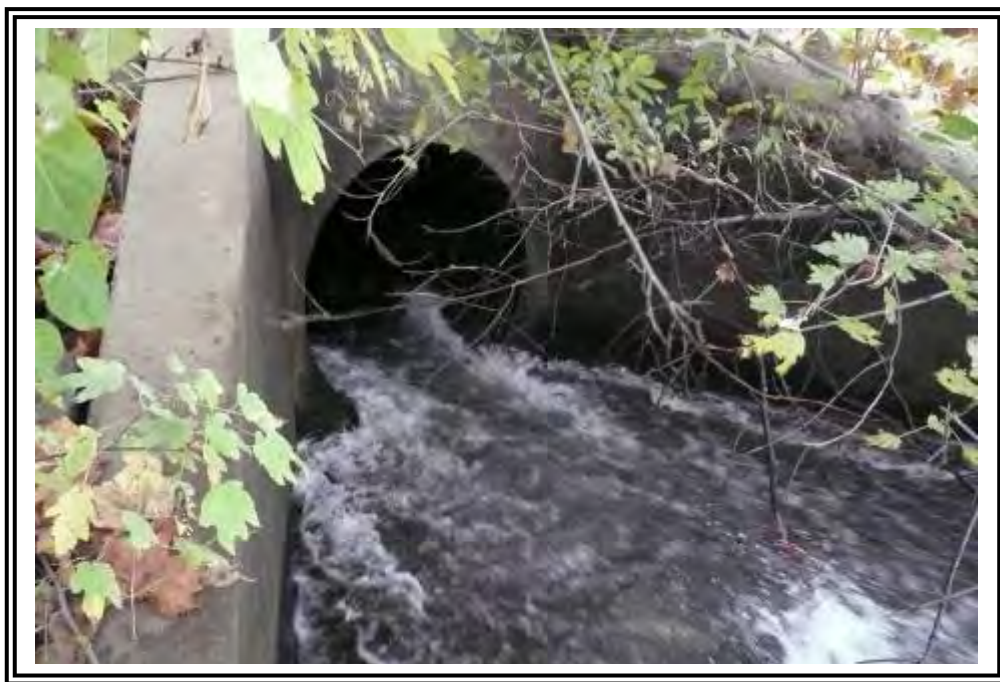
84

A close up of the outfall to the river from Pond 7A.

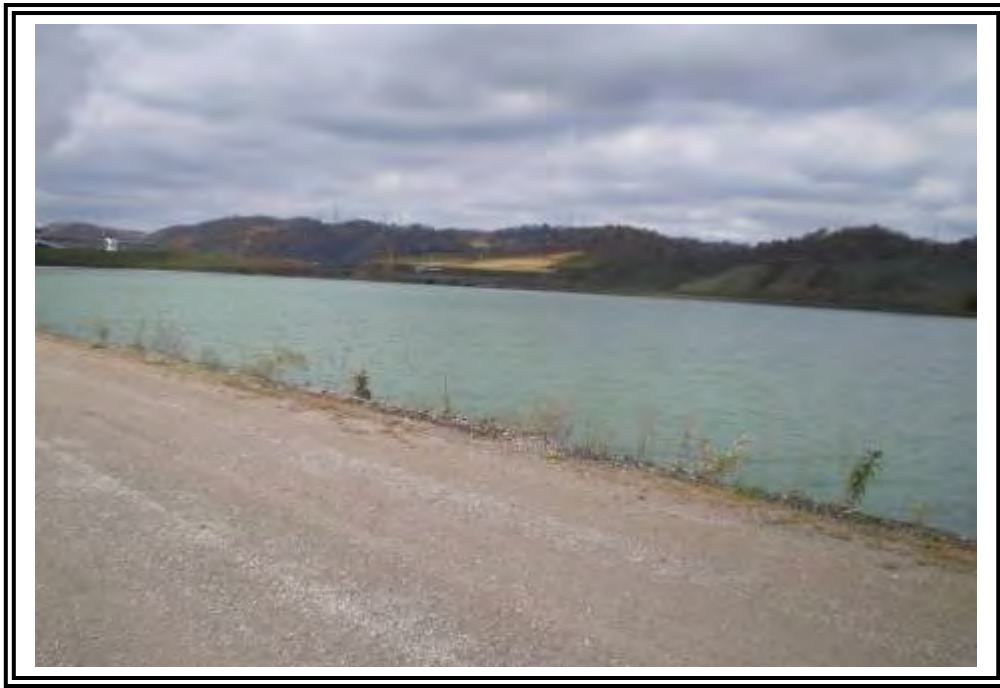
85

Looking northwest across Pond 7.

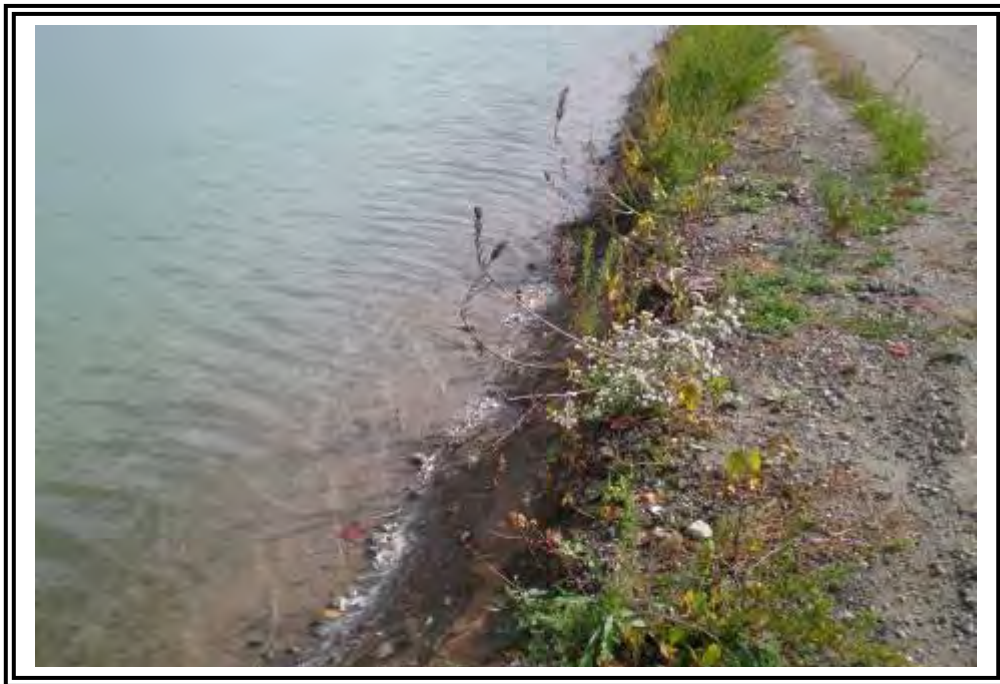
86

Close up of upstream slope of Pond 7 south dike.

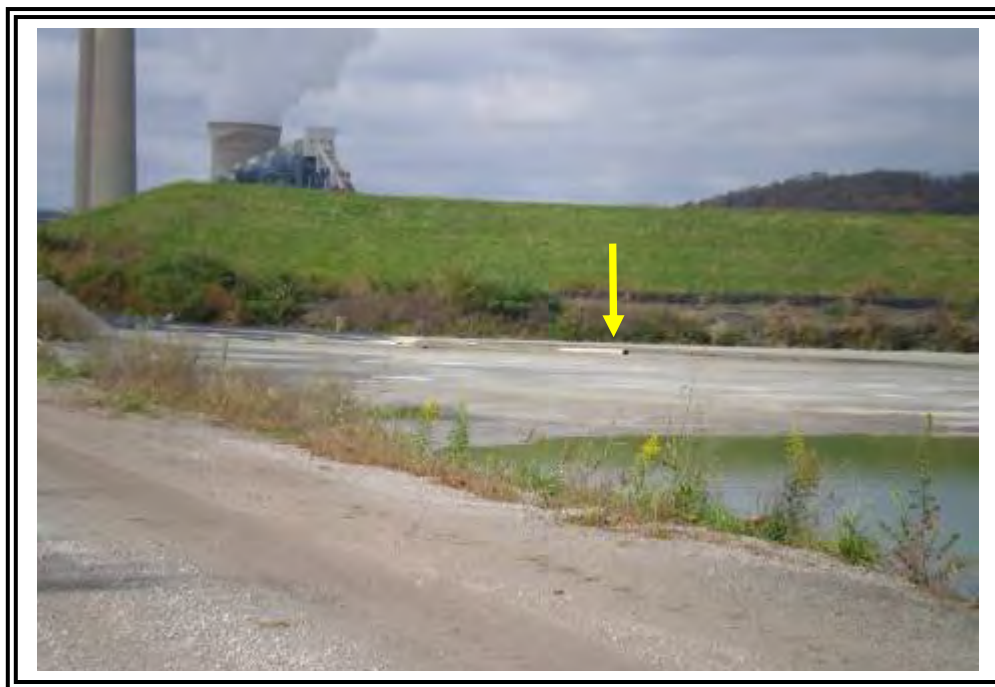
87

Looking at the southwest corner of Pond 7 showing ash delta and sluice lines (arrow).
Pond 3A's east dike is in the background.

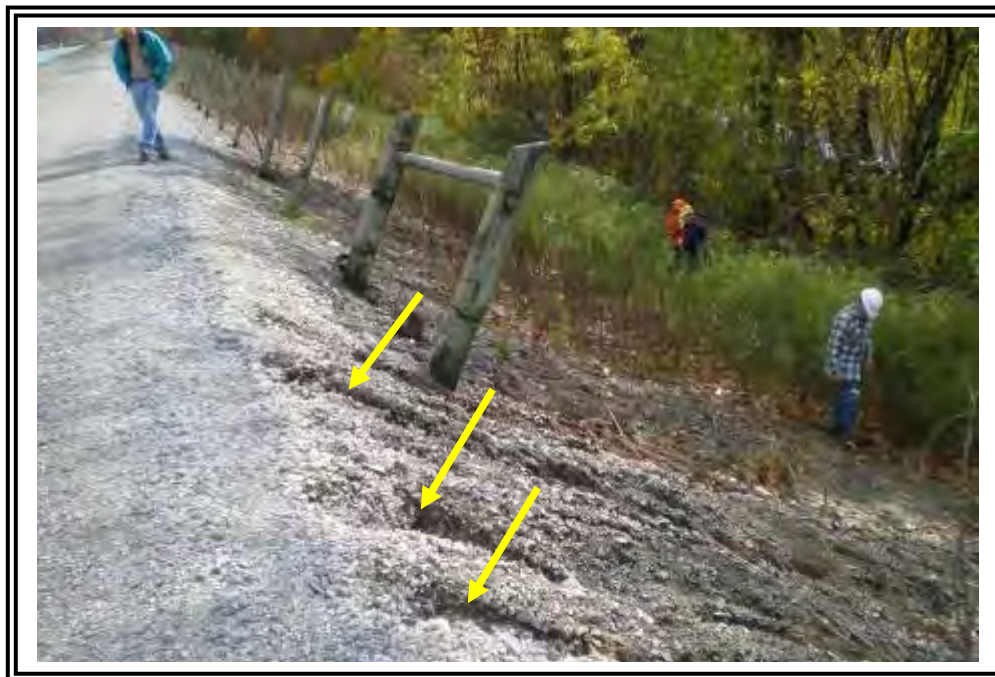
88

Looking east along the crest and downstream slope of Pond 7 south dike. Note erosion rills in slope (arrows).

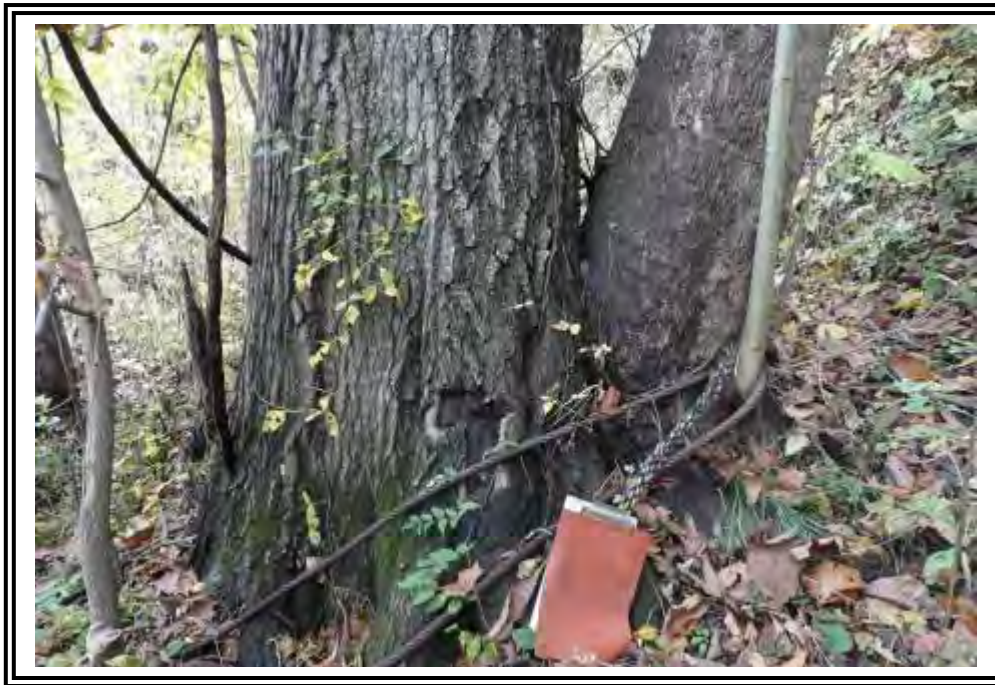
89

A close up of a large tree on the downstream slope of Pond 7 south dike near the Ohio River bank.

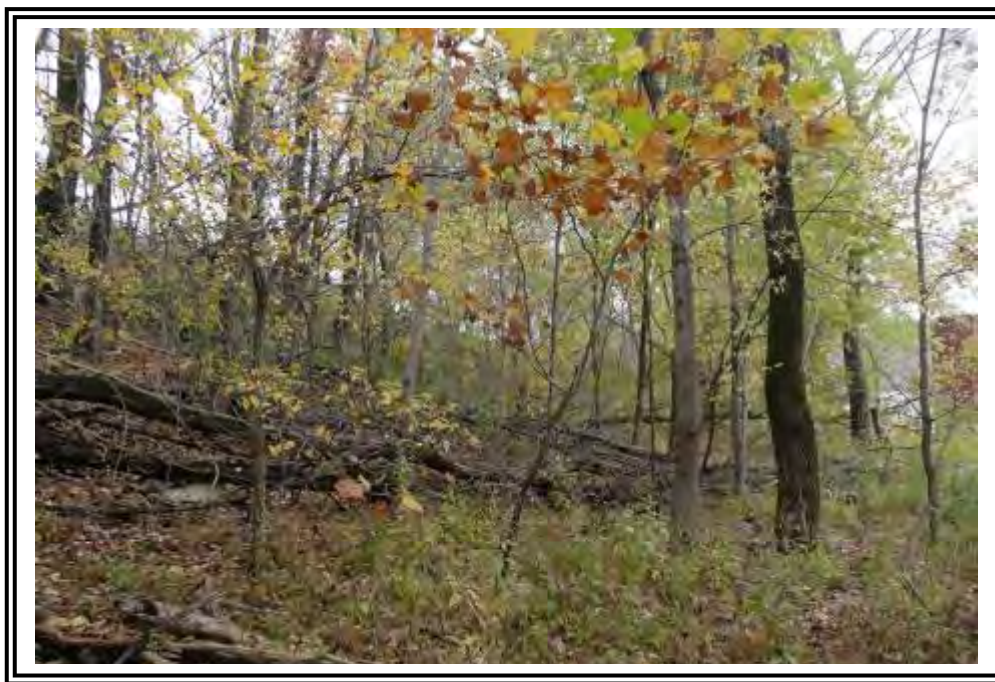
90

Looking east along the toe of the Pond 7 south dike near the Ohio River bank.
